TEST REPORT

Lucideon Reference: 155545 (QT38443/1/DT)/Ref. 1/Supp1

Project Title: Accelerated Weathering Tested to ETAG 034 and TS EN 772-22 on a Jesmonite GRC Grade 18. Metallic Panel

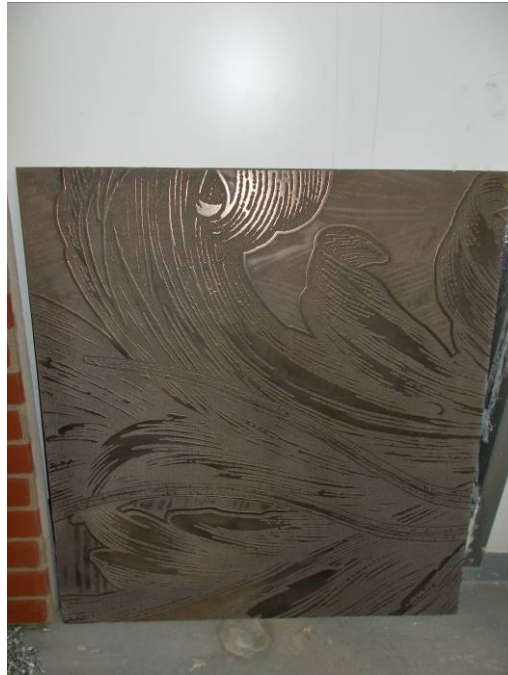
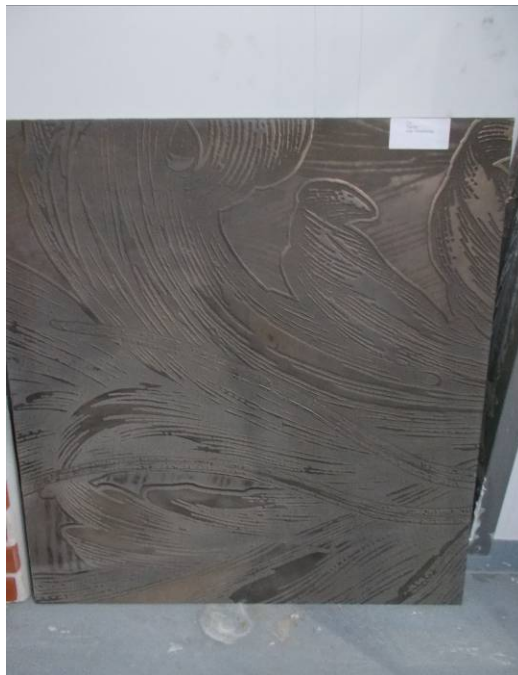
Plate 1 - Before and After Weathering of the Jesmonite GRC Grade 18. Metallic Panel

Note variation in colour due to lighting conditions. No visual damage.
